1215 McCormick Road

A Presentation in Two Acts

Act One – Residence

Act Two – Barn

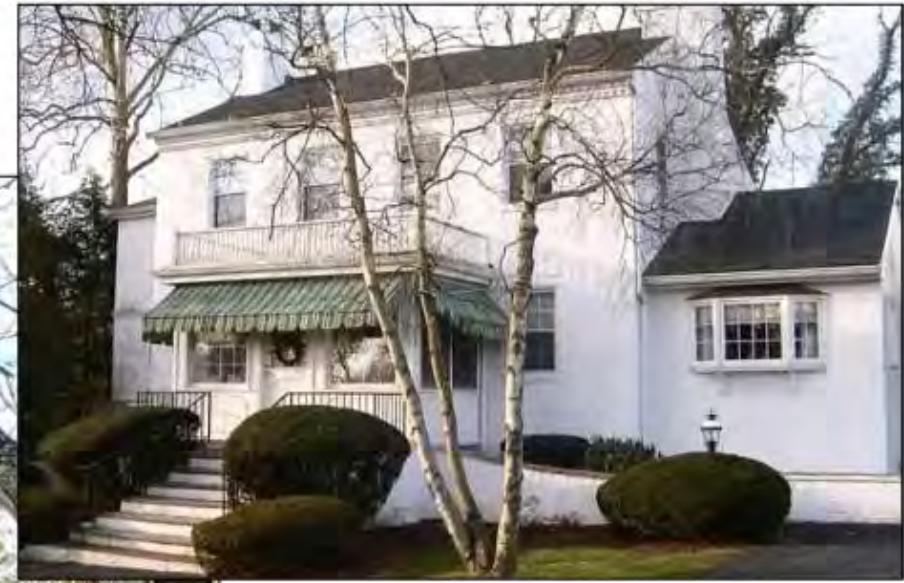
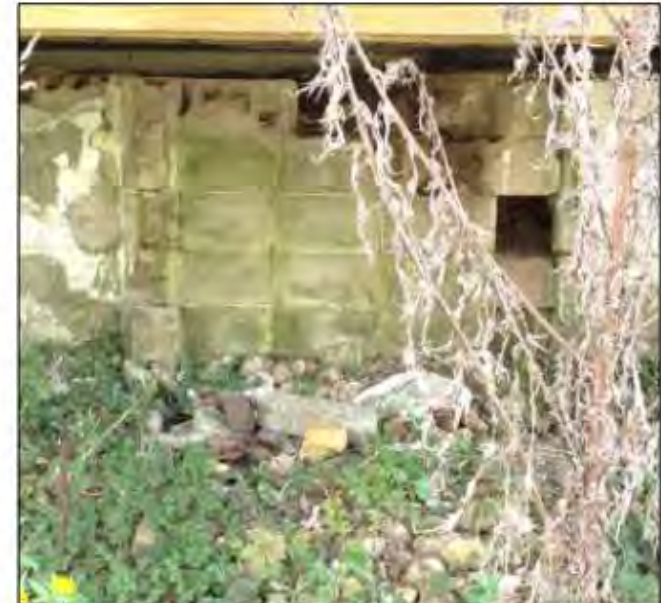
Central Stairs Have Been Removed

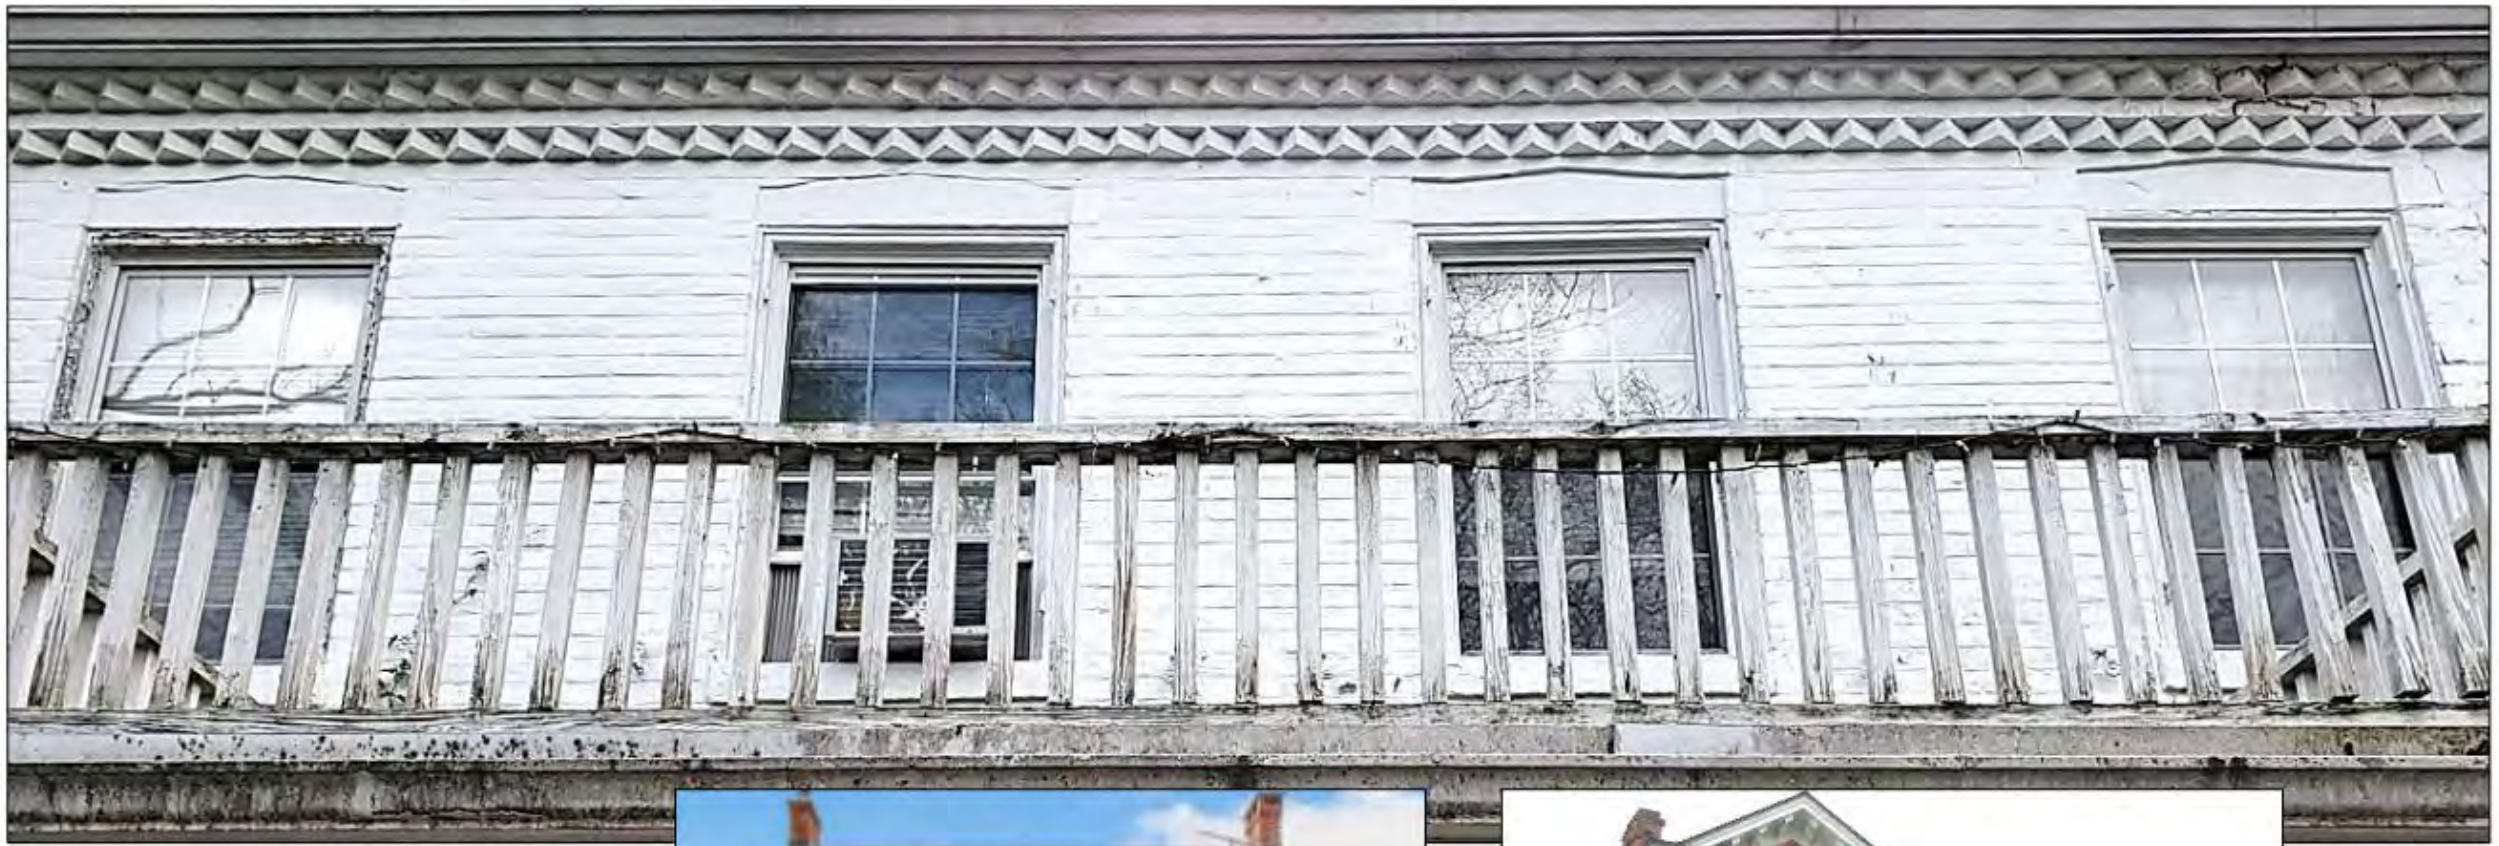
Inconsistent Window Headers

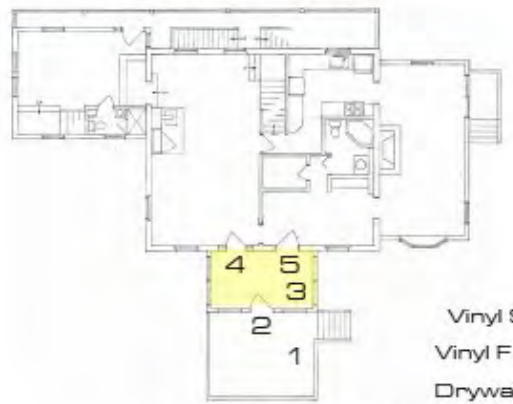
Entry Vestibule

- Vinyl Siding
- Vinyl Flooring
- Drywall Walls
- Hot Water Heat with No Air Conditioning
- Aluminum Windows
- Wood Sills Rotted

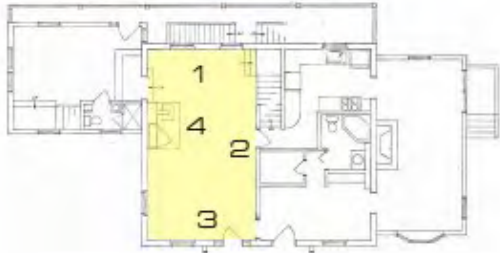
Living Room

Plaster Walls

Hot Water Heat with
No Air Conditioning

Electric Wire Molding

Wood Stove & Cupboard Have
Replaced Original Fireplace

Wood Flooring Overlay

Replacement Windows

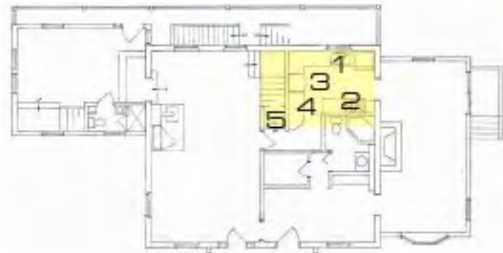
Kitchen

Plaster & Drywall Walls

Electric Heat - No Air Conditioning

Dated Electric Appliances

One Duplex Outlet

Ceramic Tile Countertops
& Backsplash

Ceramic Tile Flooring Overlay

Replacement Window

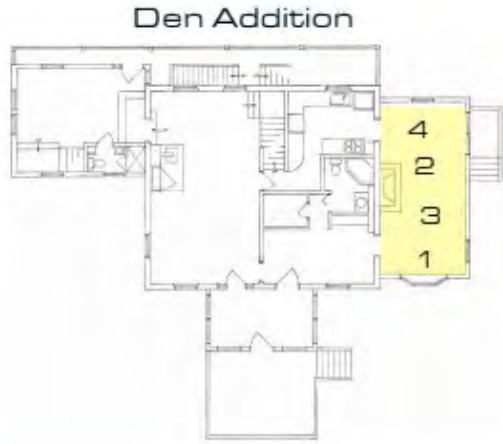
- Wood Stud Construction
- Hardwood Flooring
- Hot Water Heat - No Air Conditioning
- "Sticky Stone" Gas Fireplace with Added Chimney
- Exposed Wood Vaulted Ceiling
- Wood Paneling Walls
- Exposed Original Brick Wall

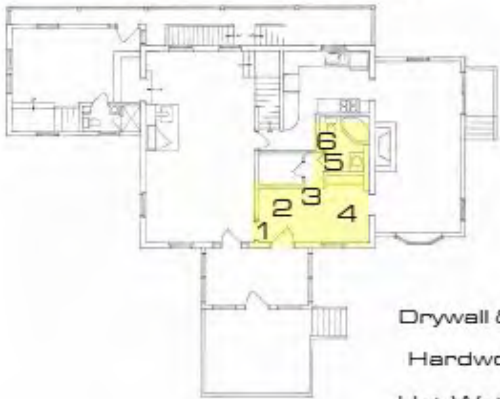
Office & Bathroom

- Drywall & Paneling Wall Construction
- Hardwood Flooring Overlay in Office
- Hot Water Heat - No Air Conditioning
- Ceramic Tile in Bathroom
- Original Fireplace (behind sink) has been removed

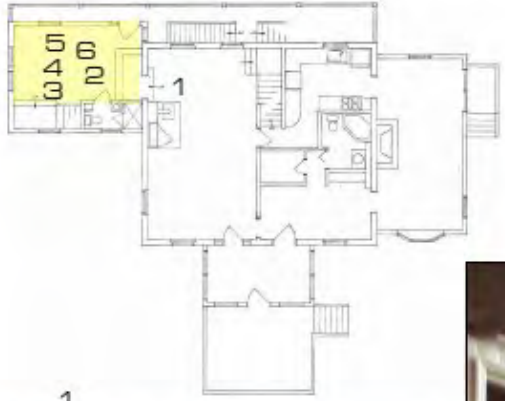
Master Bedroom
Main Level

- Two Story Space
- Lots of Stairs
- Drywall & Paneling Wall Construction
- Carpet Flooring
- Hot Water Heat
- Air Conditioning (mini-split)
- Closets Located Upstairs

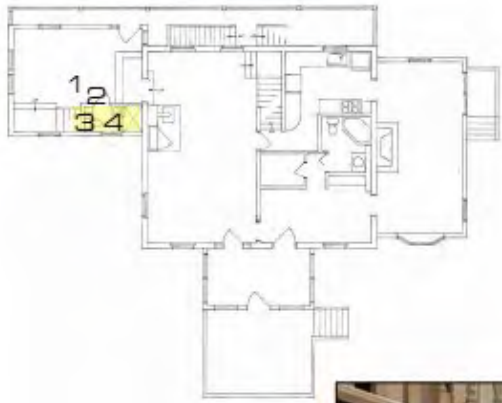
Master Bathroom

Room is 3'-6" Wide
Drywall & Paneling Wall Construction
Porcelain Tile Flooring
Ceramic Tile Shower
Electric Heat - No Air Conditioning

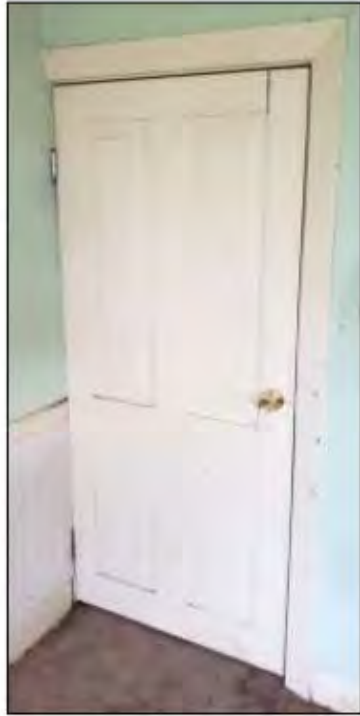
Front North Bedroom

Moisture Penetration Issue

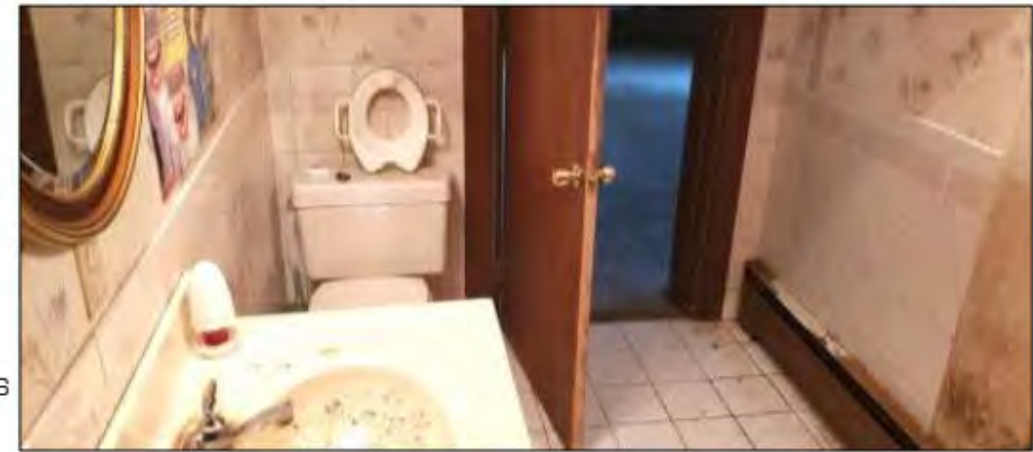
Utility Room & Bathroom

Drywall Construction
Porcelain Tile Flooring
Drywall Ceiling
Hot Water Heat - No Air Conditioning

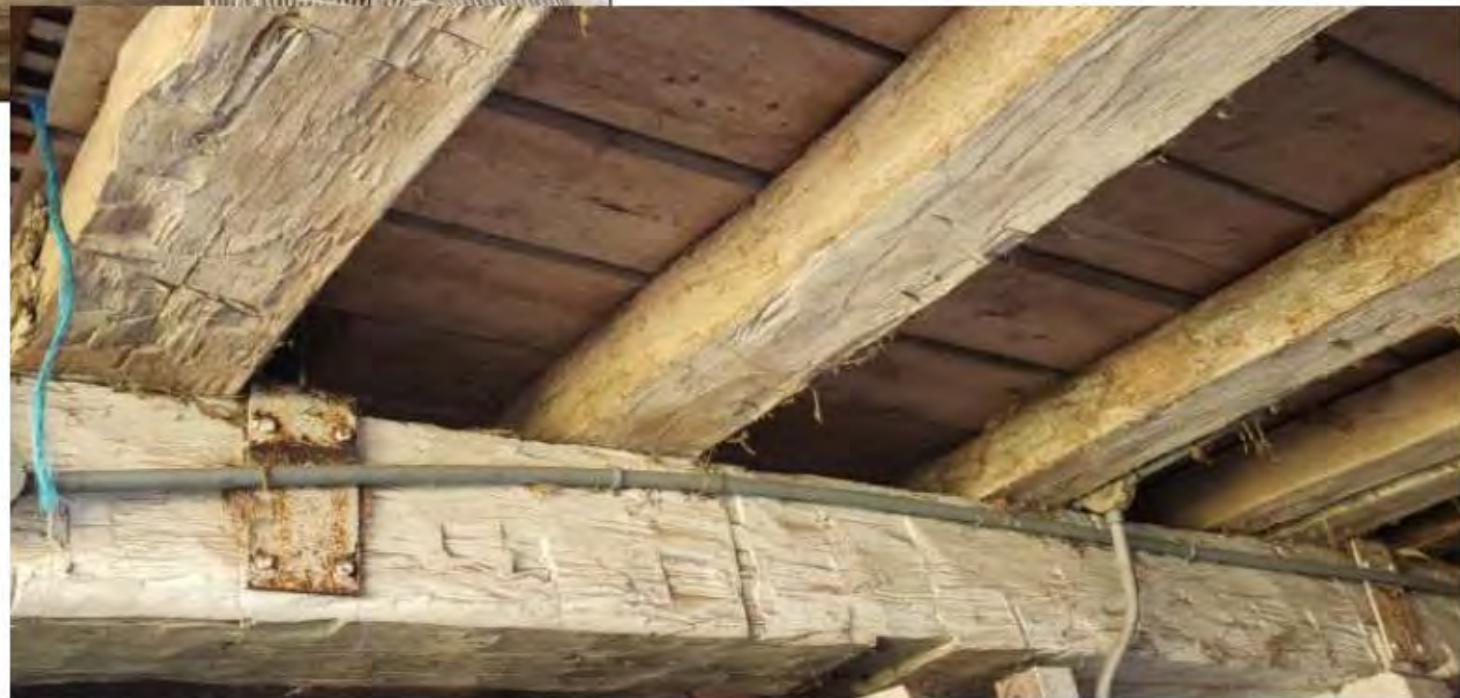
Location of Steel Beams

Inserted Steel Beams
Inside Barn

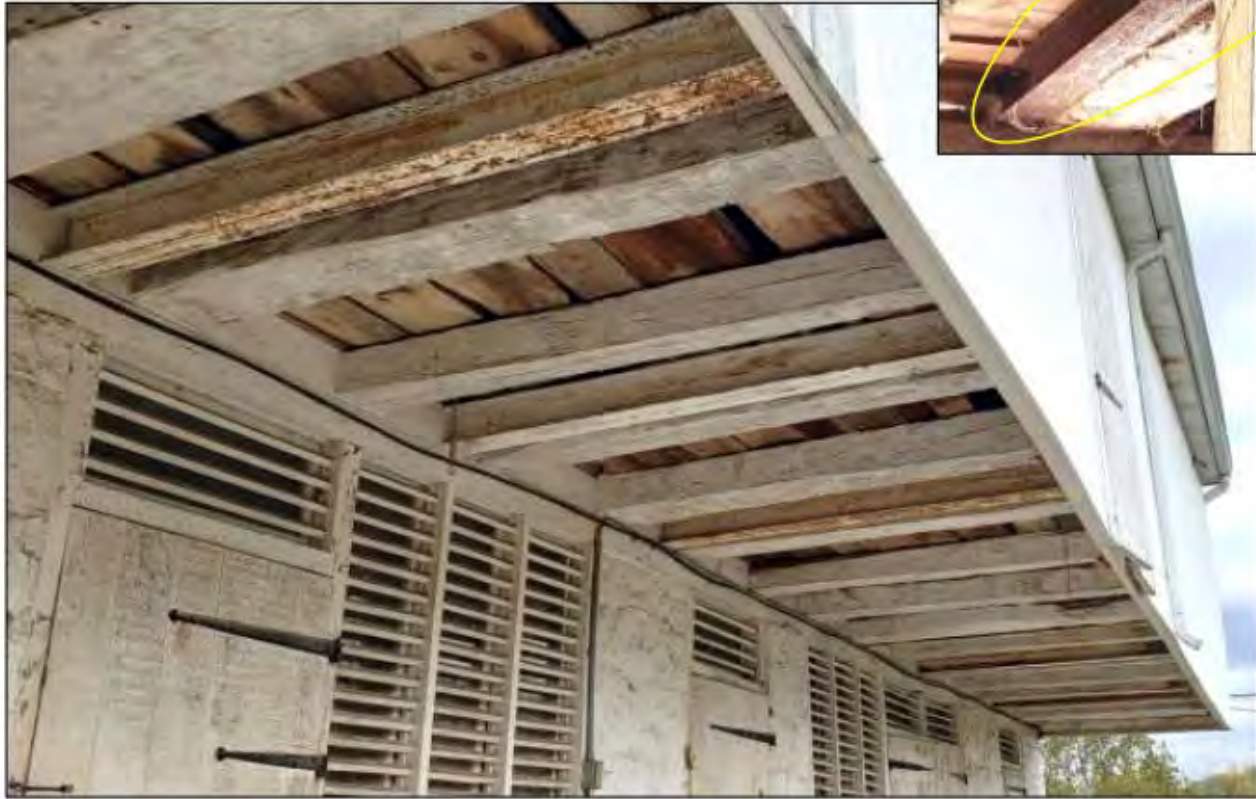
Steel Beams Extended
Outside at Overhang

Inserted Steel Structure
