1215 McCormick Road

A Presentation in Two Acts

Act One – Residence

Act Two – Barn

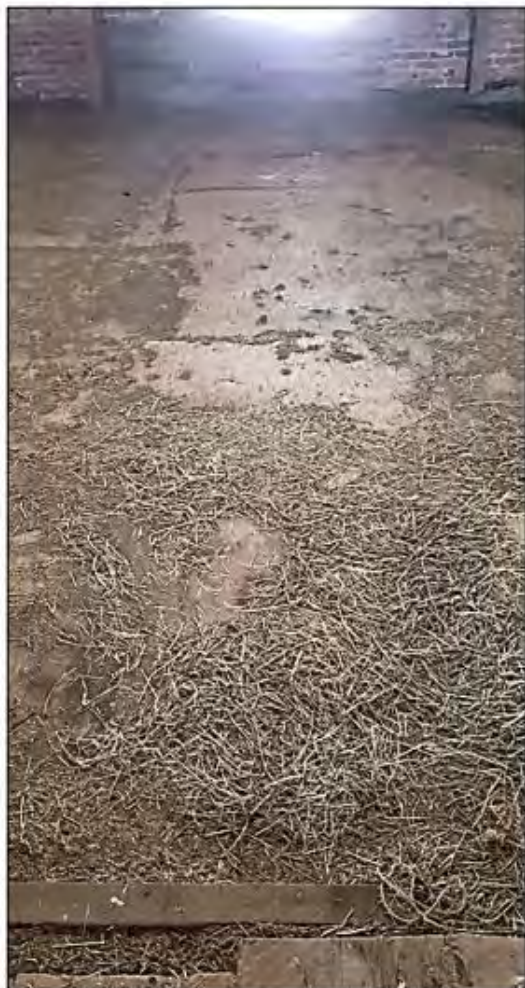
Plywood Flooring at West End
