1215 McCormick Road

A Presentation in Two Acts

Act One – Residence

Act Two – Barn

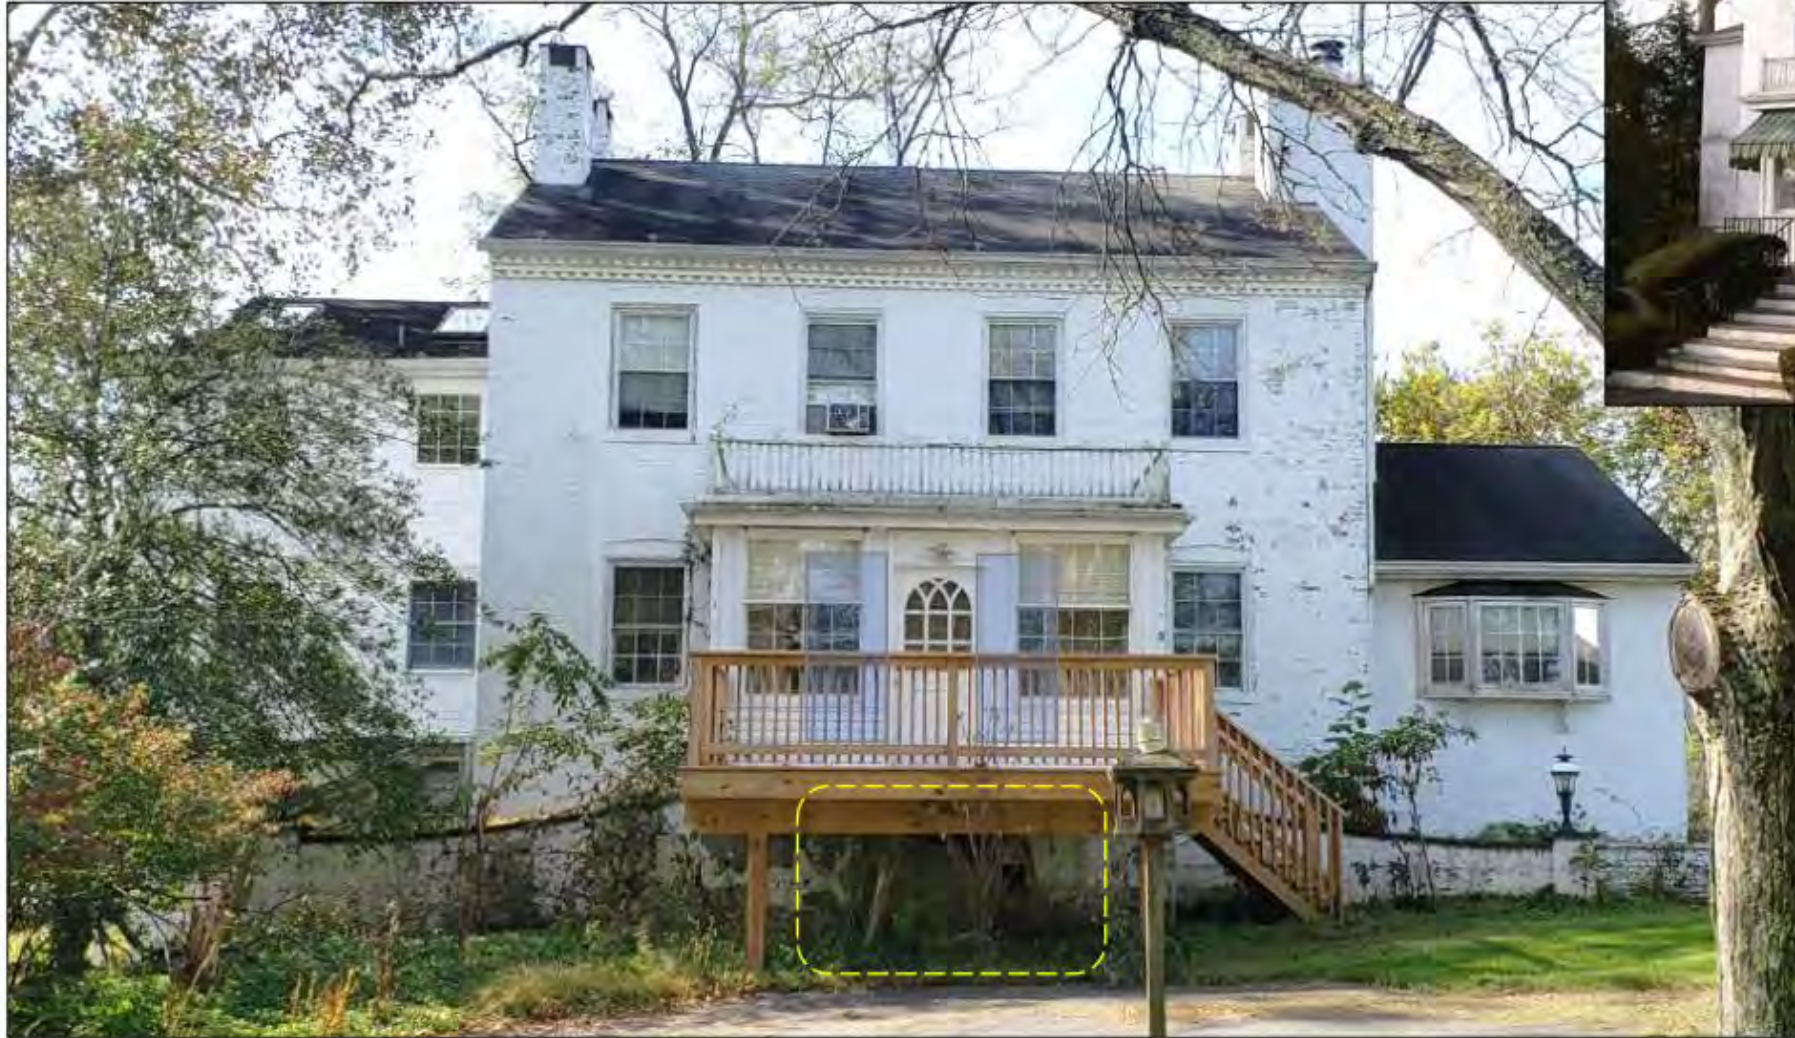
Central Stairs Have Been Removed

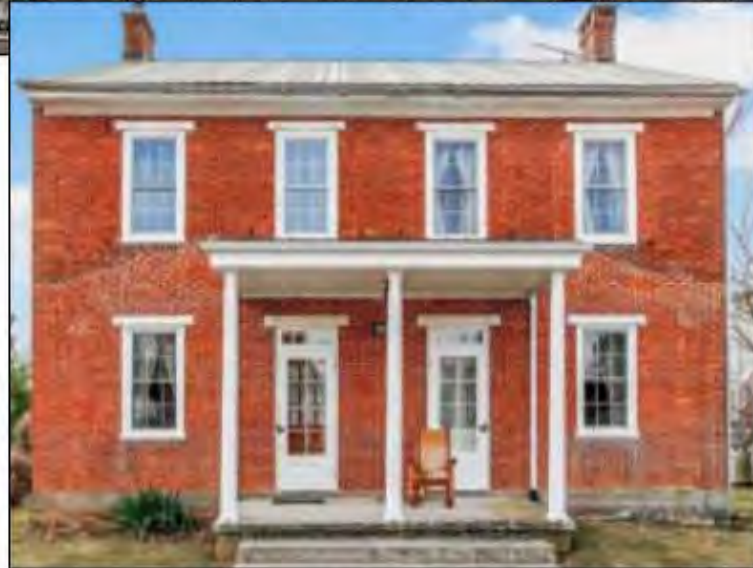
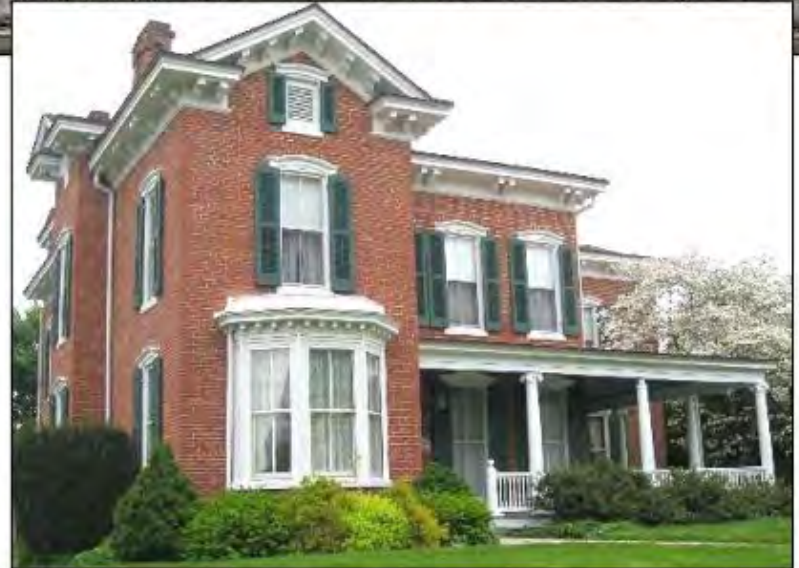
Inconsistent Window Headers

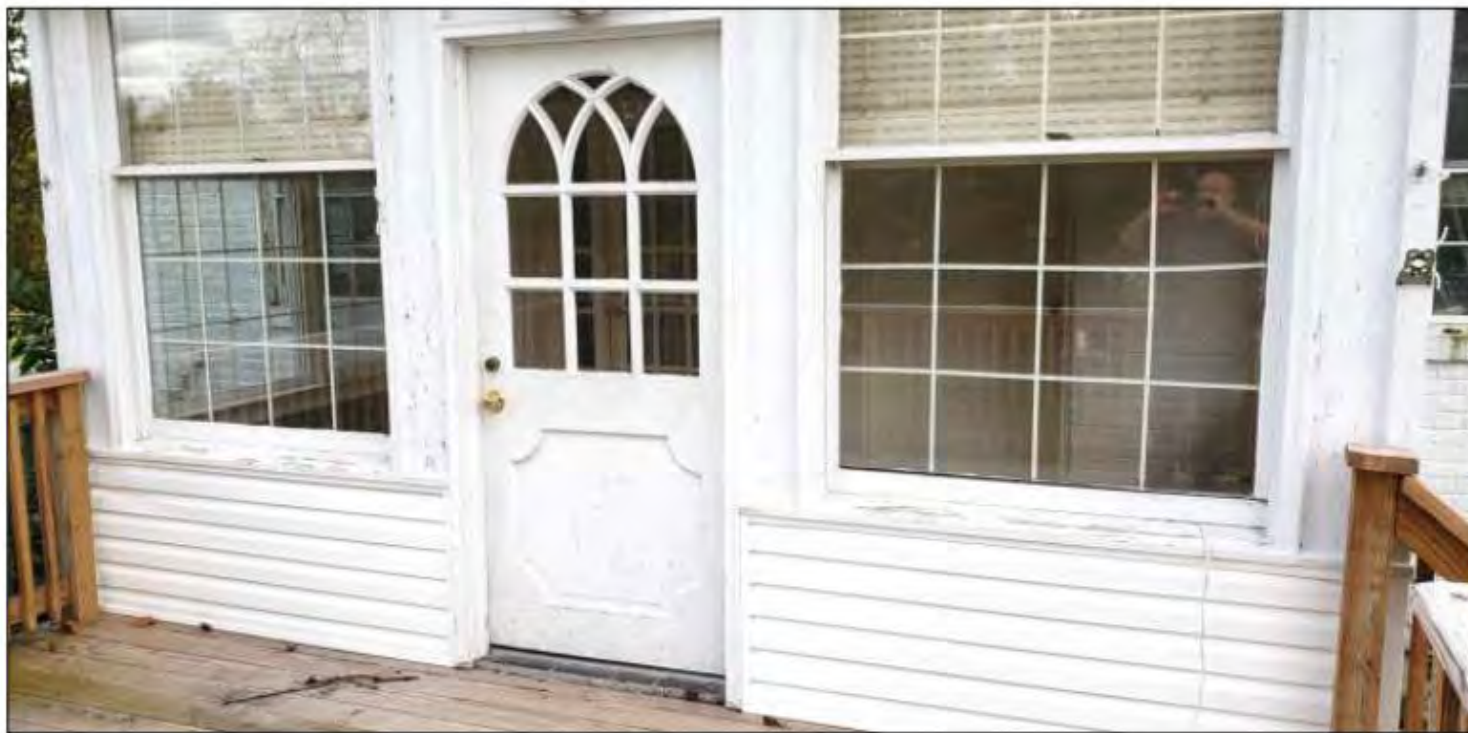
1

Entry Vestibule

- Vinyl Siding
- Vinyl Flooring
- Drywall Walls
- Hot Water Heat with No Air Conditioning
- Aluminum Windows
- Wood Sills Rotted

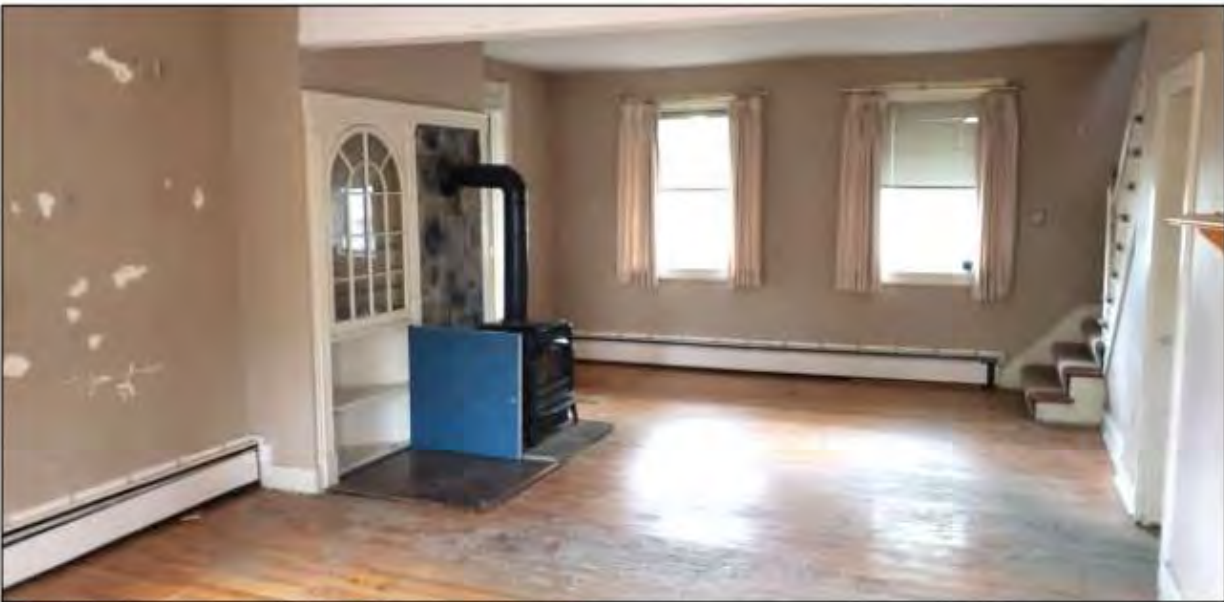
1

Plaster Walls

Hot Water Heat with
No Air Conditioning

Electric Wire Molding

Wood Stove & Cupboard Have
Replaced Original Fireplace

Wood Flooring Overlay

Replacement Windows

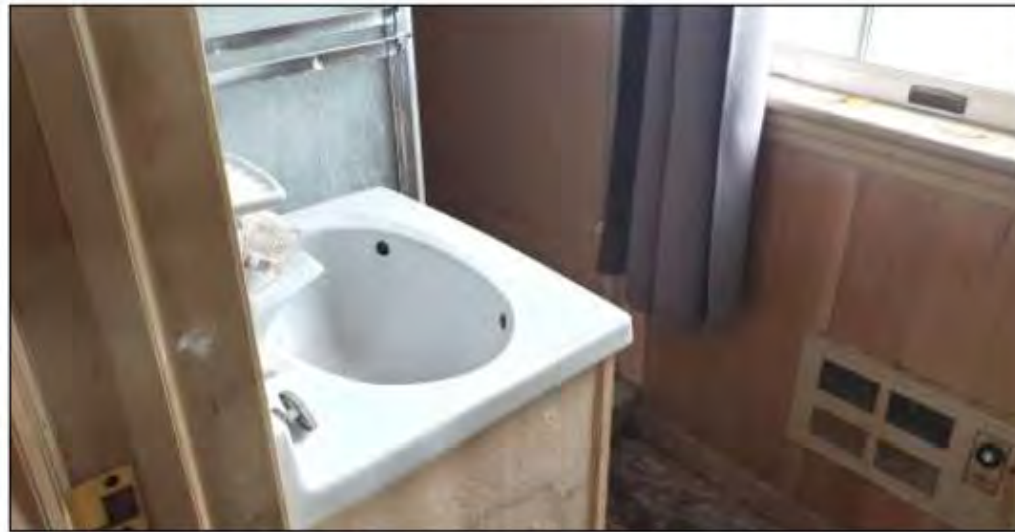
2

Room is 3'-6" Wide
Drywall & Paneling Wall Construction
Porcelain Tile Flooring
Ceramic Tile Shower
Electric Heat - No Air Conditioning

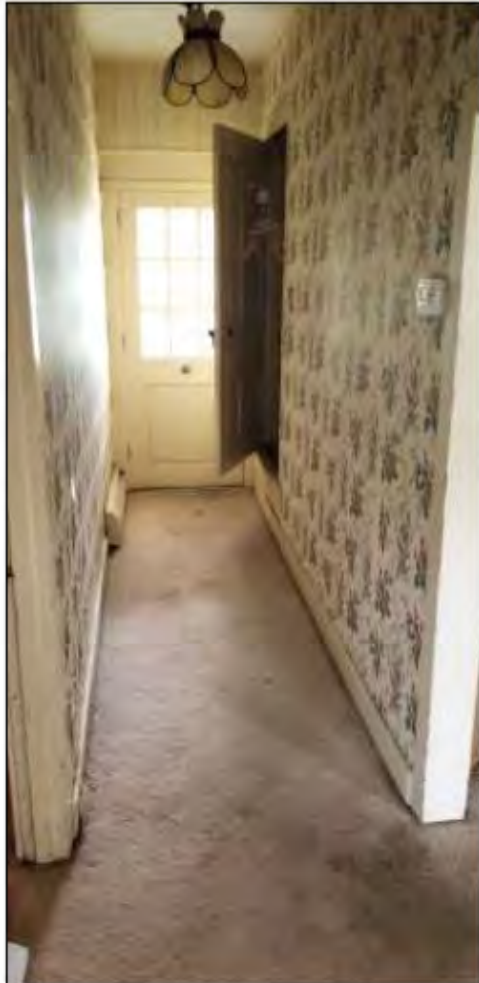
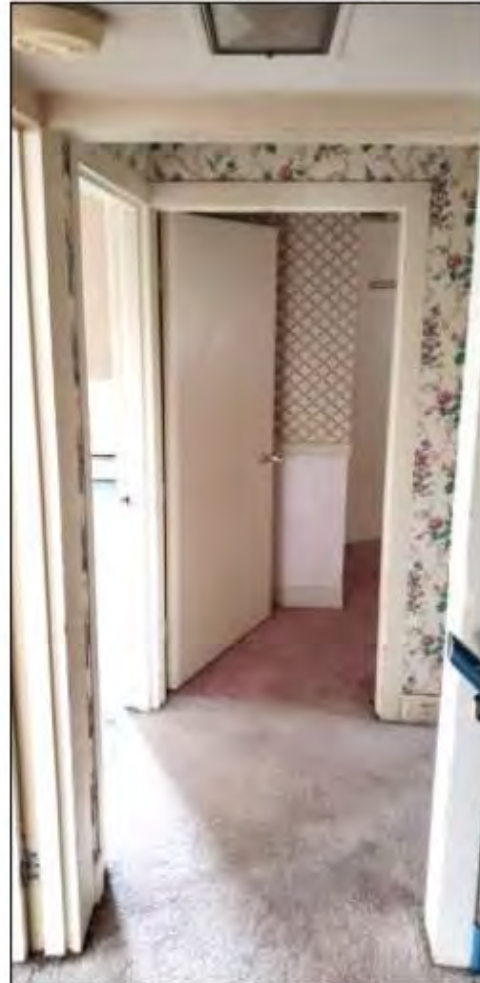
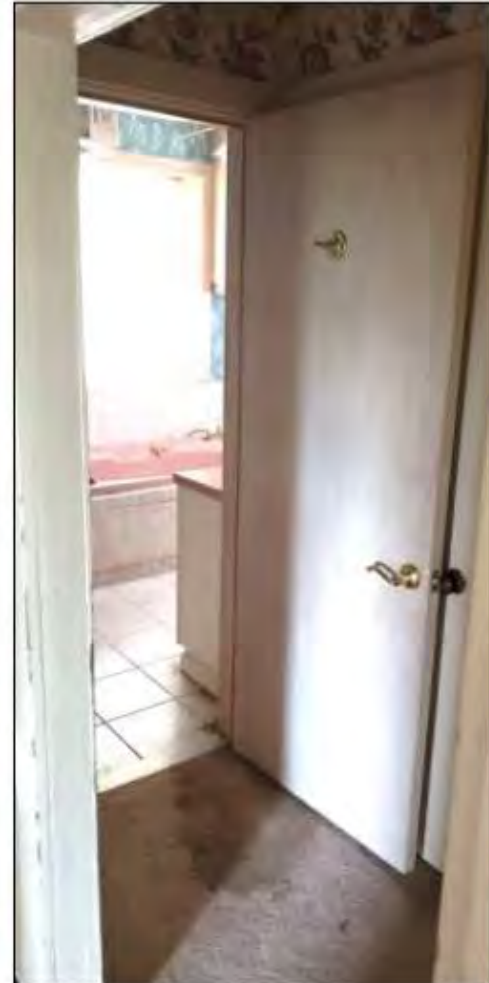
Stairs & Hallway

Stairs 2'-9" Wide

Hallway 3'-3" Wide

Drywall Wall Construction

Carpet over Wood Flooring

Hot Water Heat - No Air
Conditioning

Door to Exterior Balcony/Stairs

No Connection Between
Master Bedroom Upper Level
and This Level

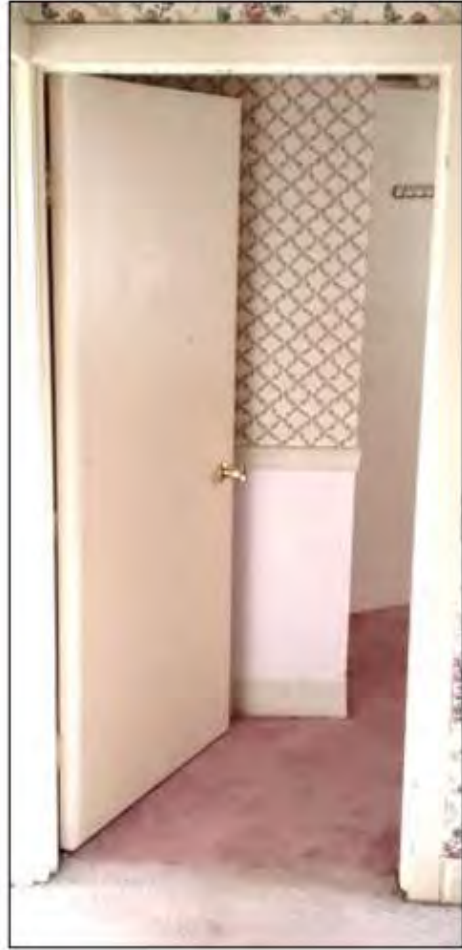
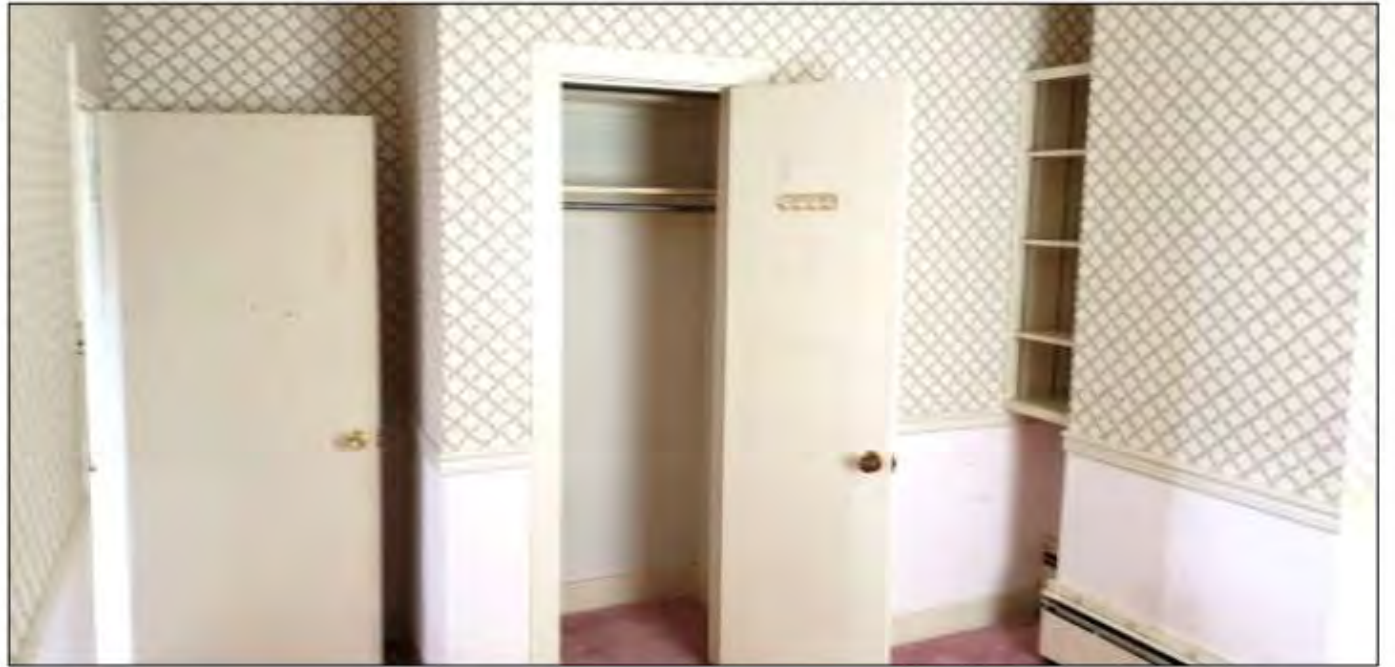
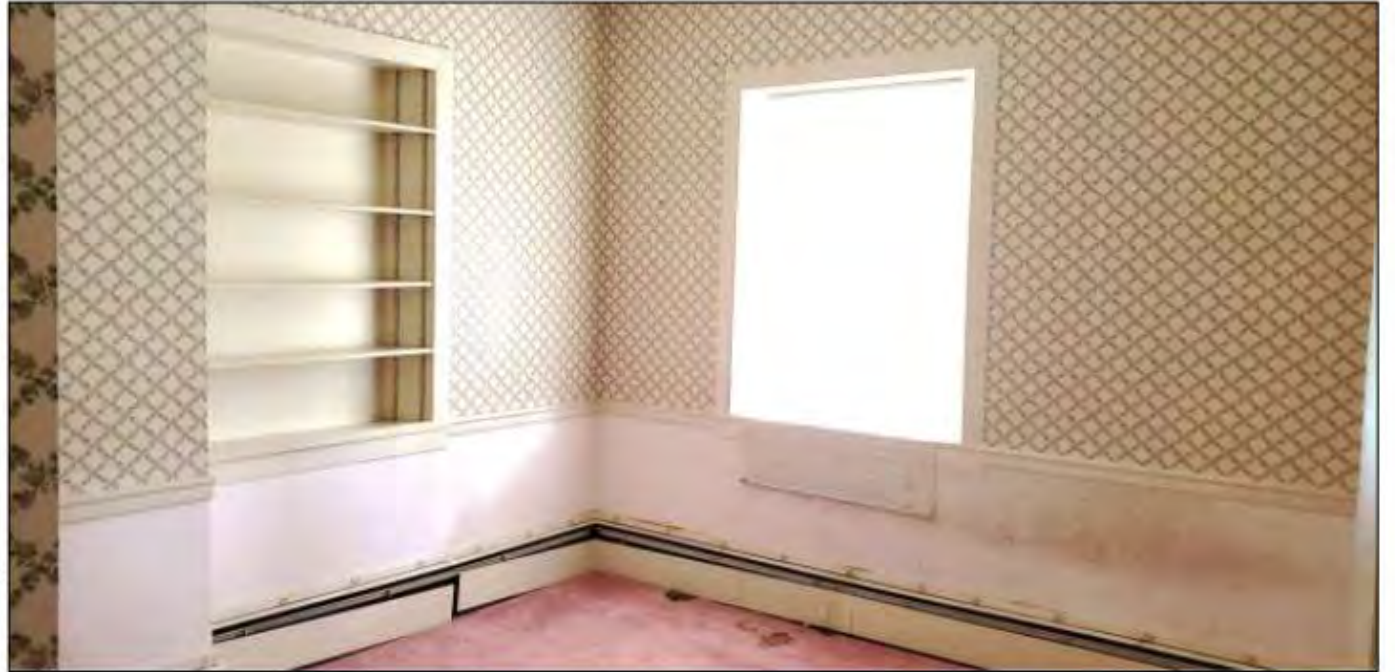
Rear Bedroom

Approx. 11' x 12'

Plaster & Drywall Walls

Carpet over Wood Flooring

Hot Water Heat - No Air
Conditioning

Electric Wire Molding

Side Window Filled In

Replacement Window

6' High Hollow Core Door

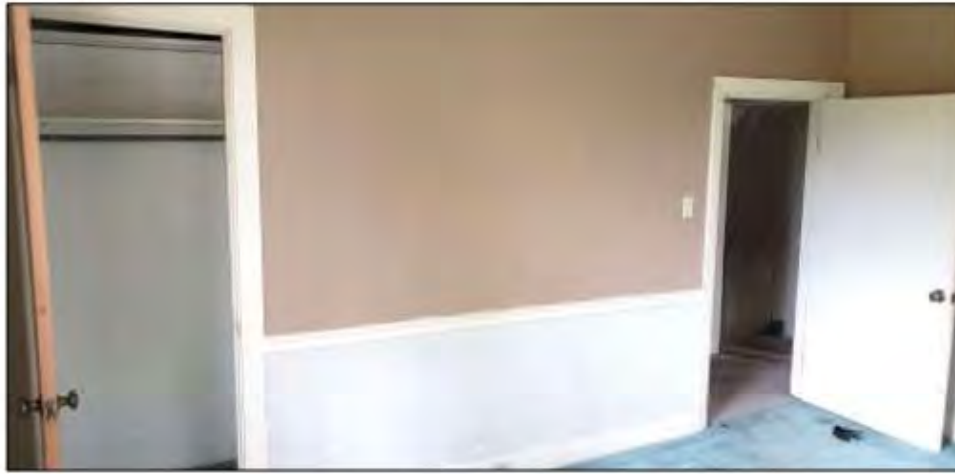
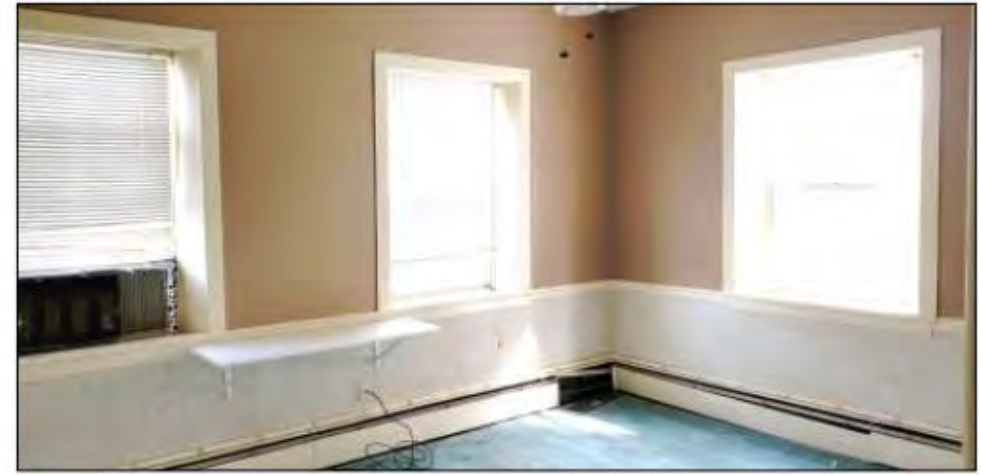
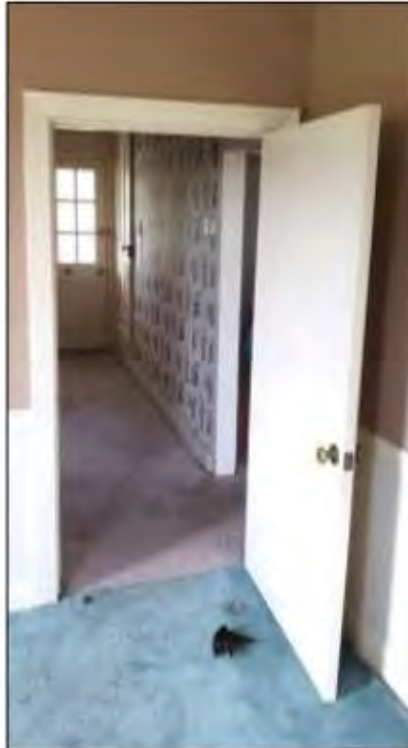
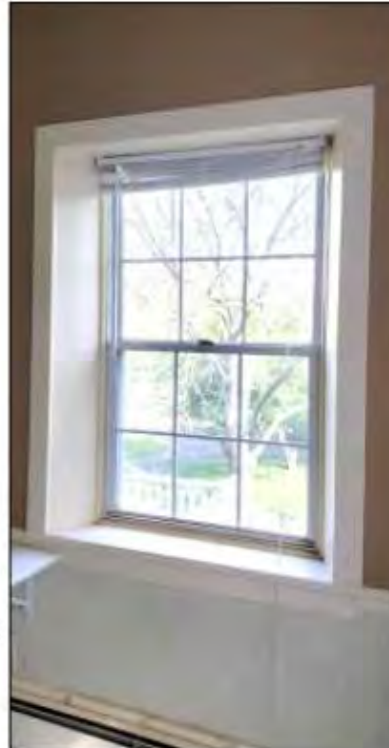
Front South Bedroom

Approx. 14'-7" x 11'

Plaster & Drywall Walls

Carpet over Wood Flooring

Hot Water Heat

Window Air Conditioning

Electric Wire Molding

Replacement Windows

6' High Hollow Core Door

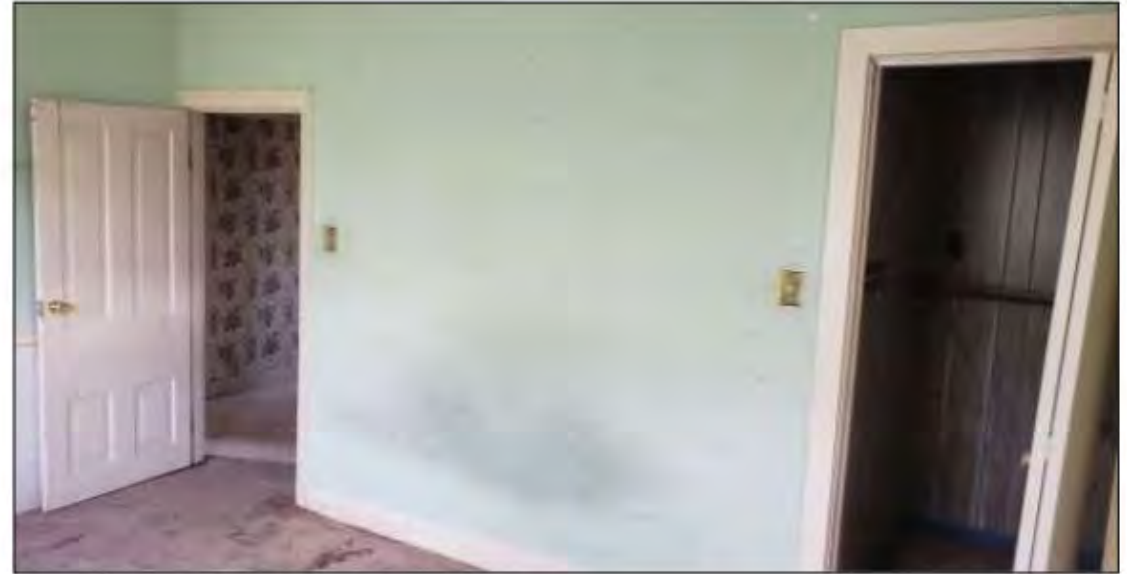
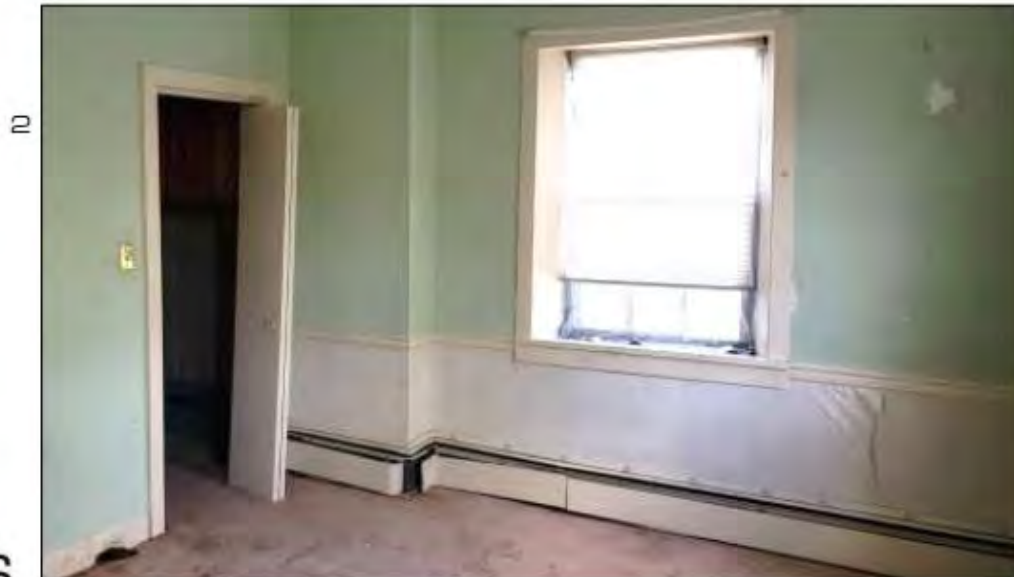
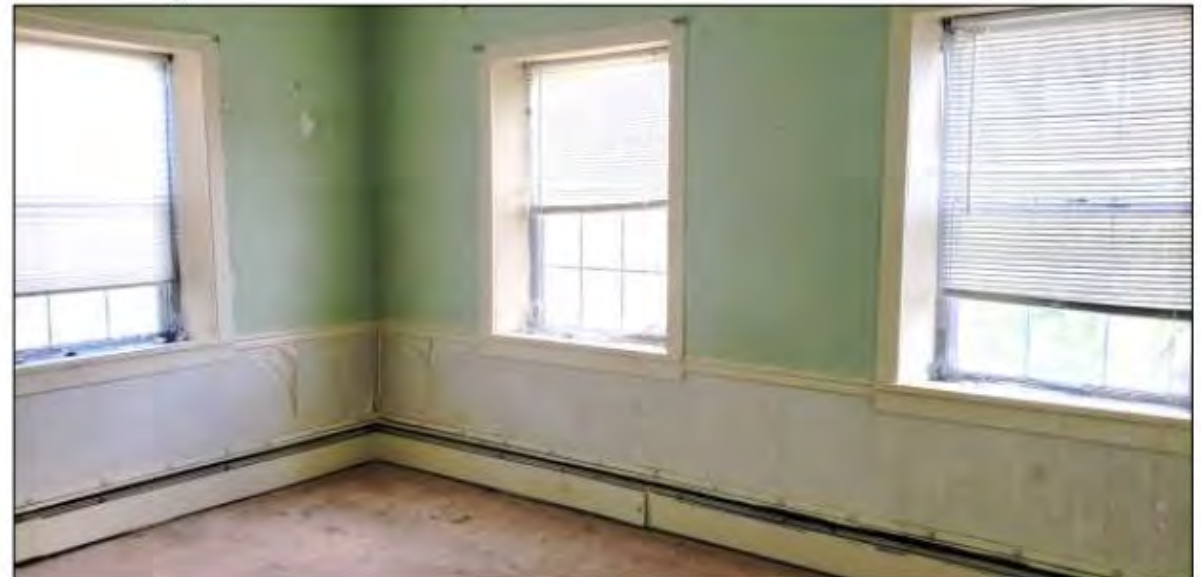
Front North Bedroom

Approx. 14'-7" x 11'

Plaster & Drywall Walls

Carpet over Wood Flooring

Hot Water Heat - No Air Conditioning

Electric Wire Molding

Replacement Windows

6' Four Panel, Solid Door with "Custom" Frame

Moisture Penetration Issue

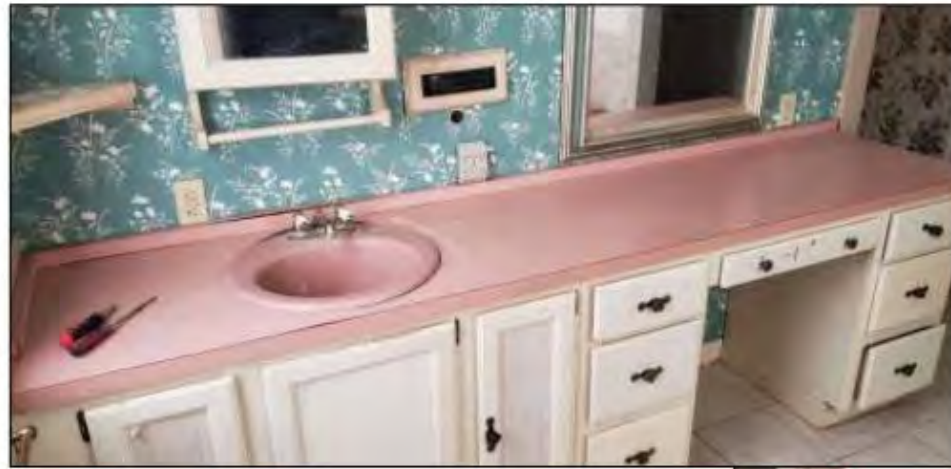
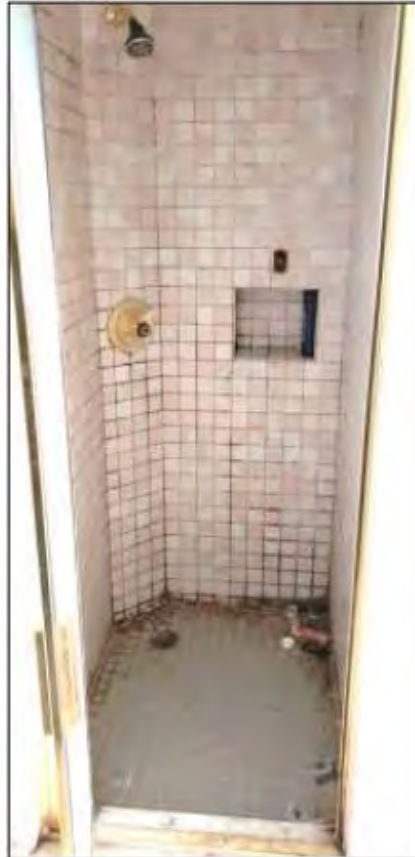
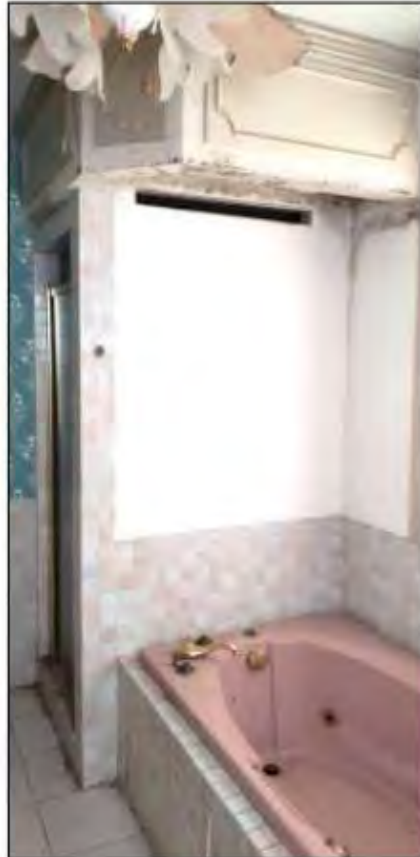
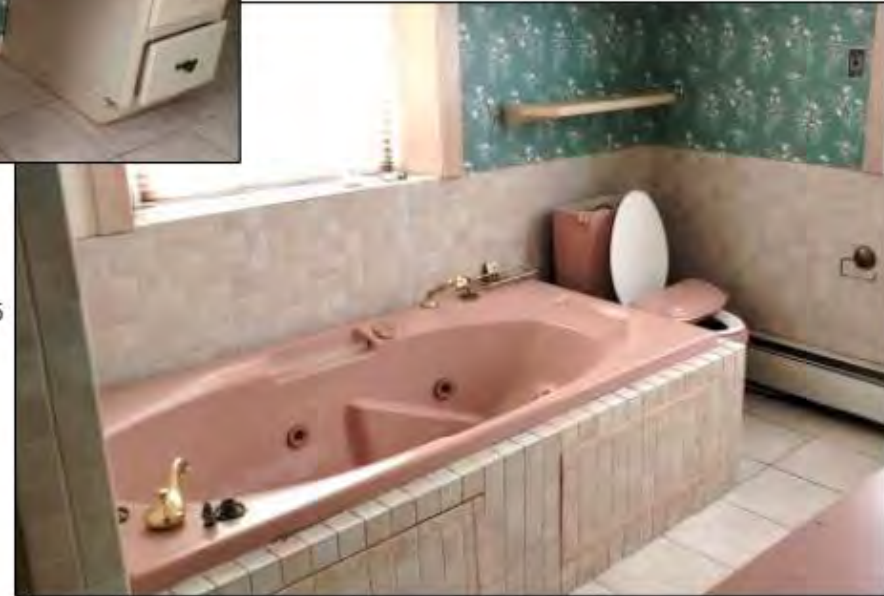
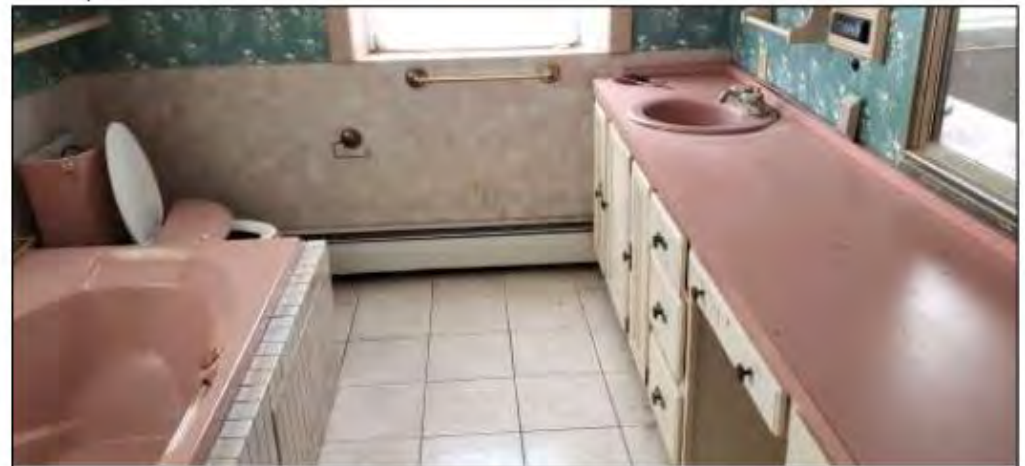
Upper Level Bathroom

Plaster & Drywall Walls

Ceramic Tile Wainscot & Shower

Porcelain Tile Flooring

Plastic Laminate Countertop

Hot Water Heat - No Air Conditioning

"Salmon" Fixtures

Jetted Tub

Replacement Windows

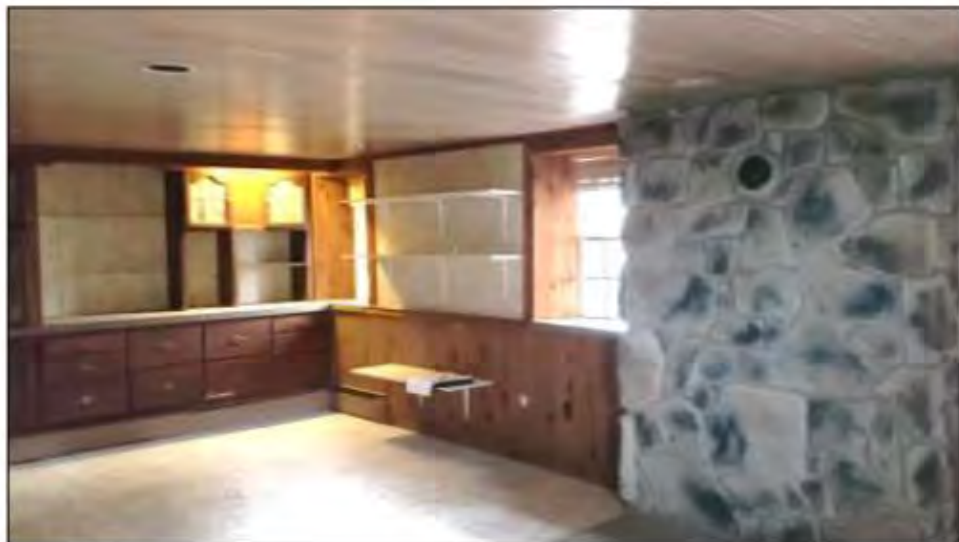
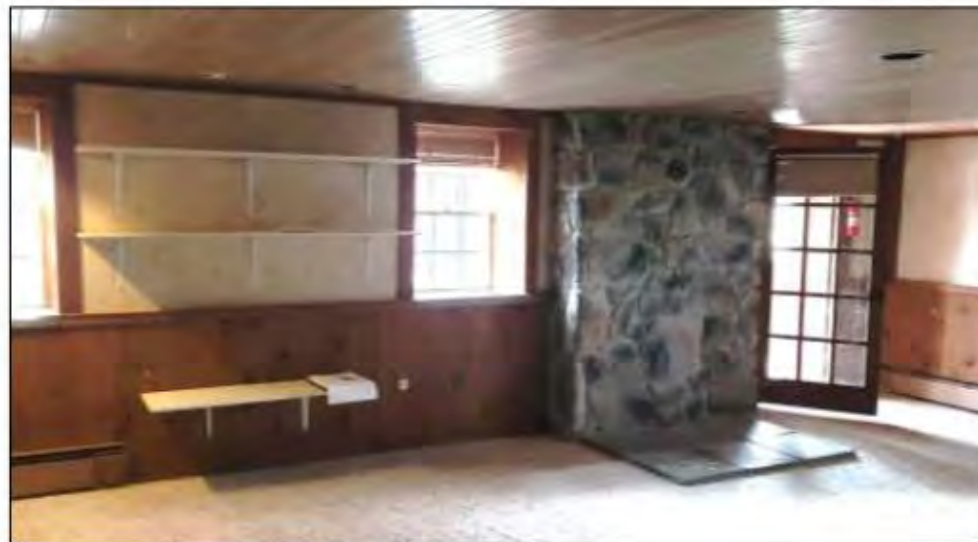
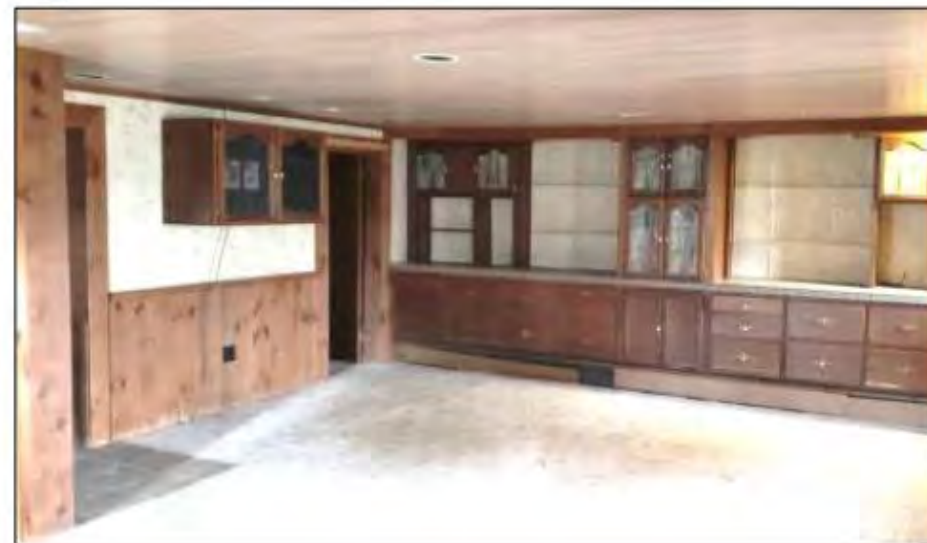
Lower Level Rec Room

Drywall Wall Construction

Wood Wainscot

Wood Ceiling

Recessed Lighting

Carpet on Concrete Flooring

Ceramic Tile Countertop

Wood Cabinetry

Hot Water Heat - No Air Conditioning

Flue for Wood Stove in Original Chimney

Replacement Windows

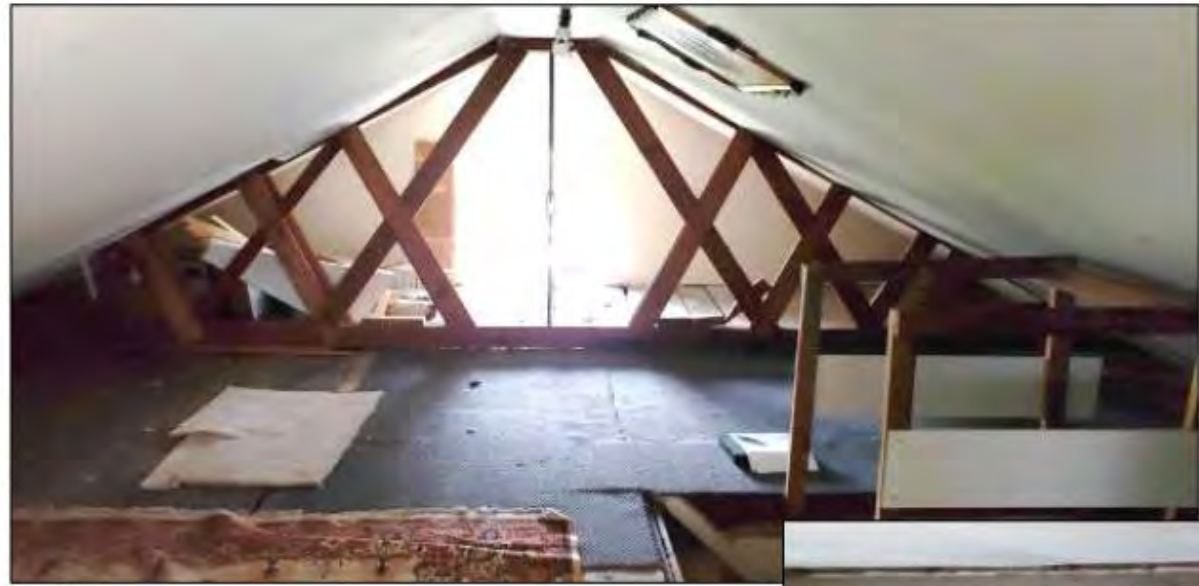
4

Truss constructed of dimensional lumber supporting roof, with iron turnbuckle supporting lower chord.

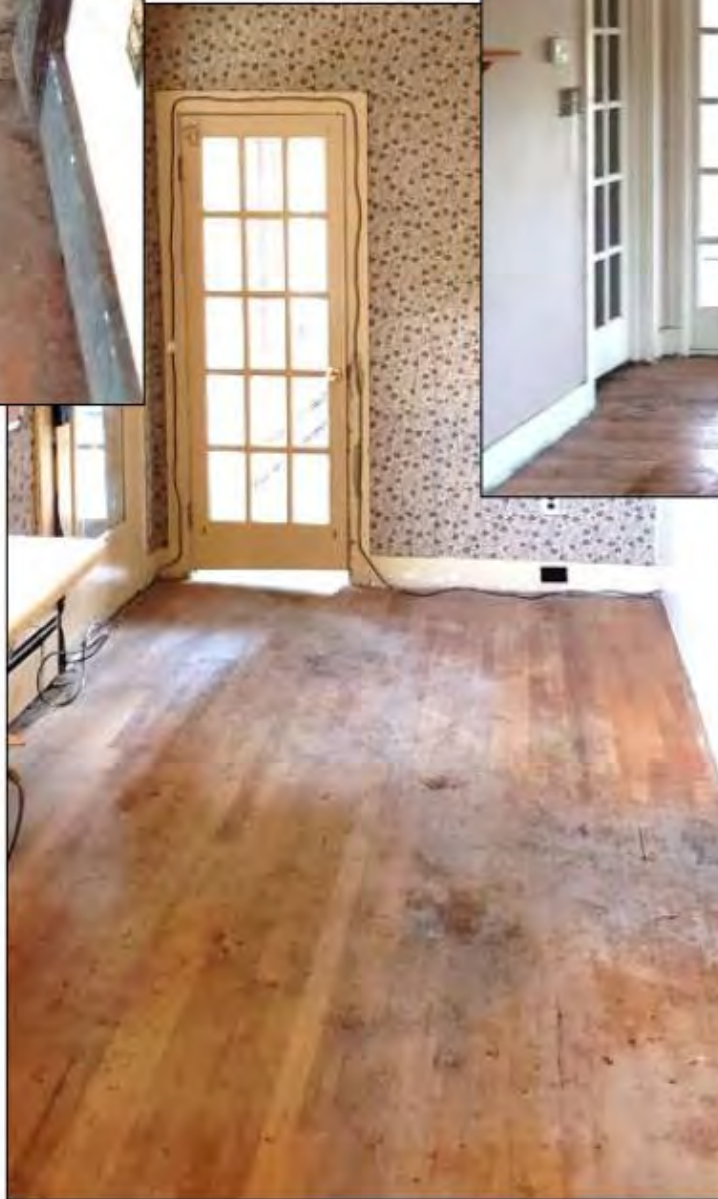
Overlaid Flooring

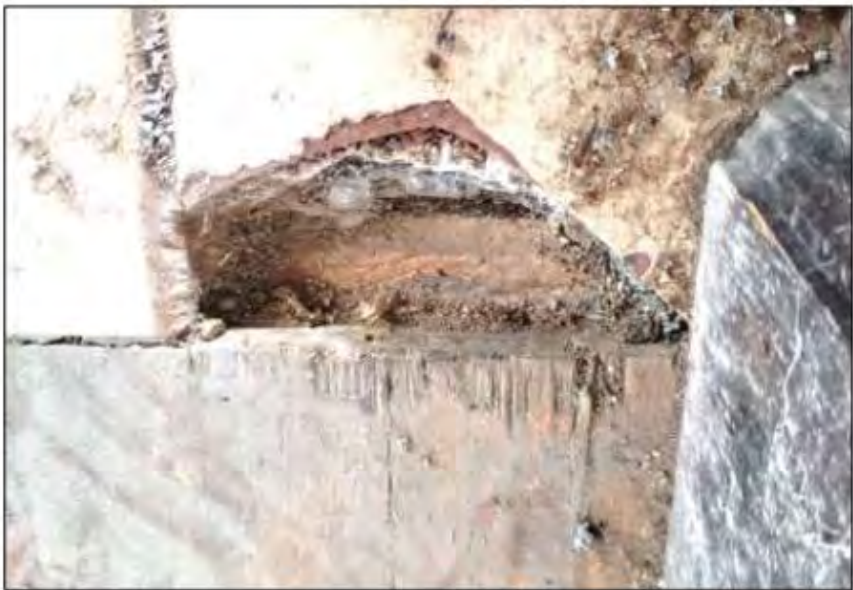
Living Room to Kitchen – Wood Flooring Underneath

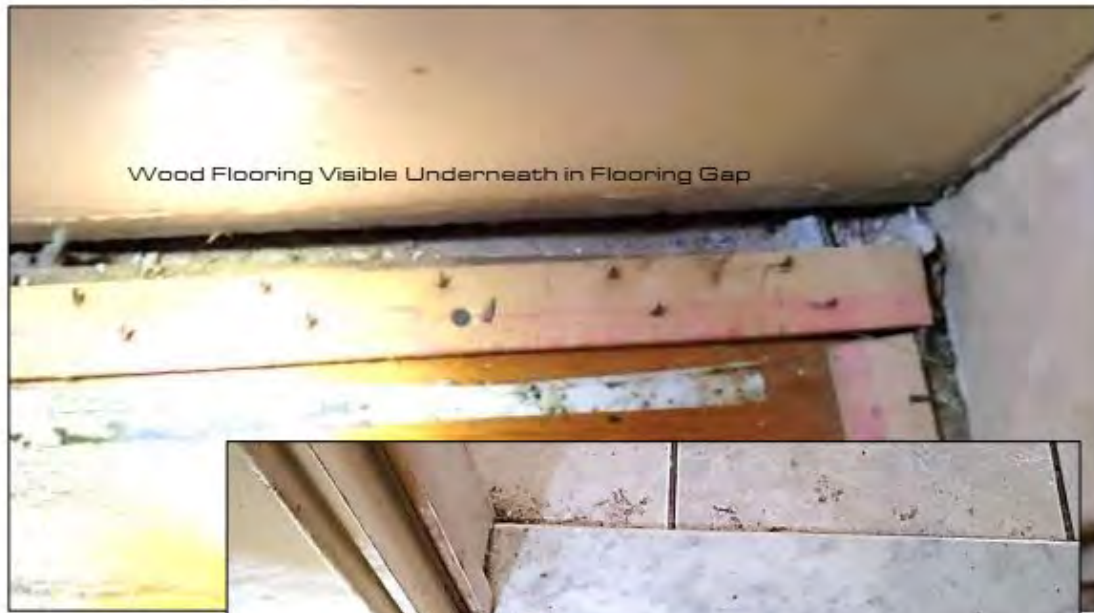
Wood Flooring Visible Underneath in Flooring Gap

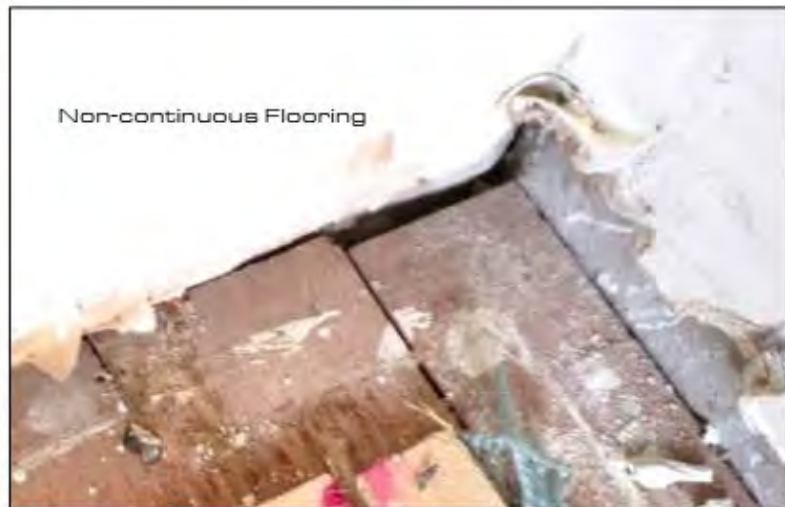
Non-continuous Flooring

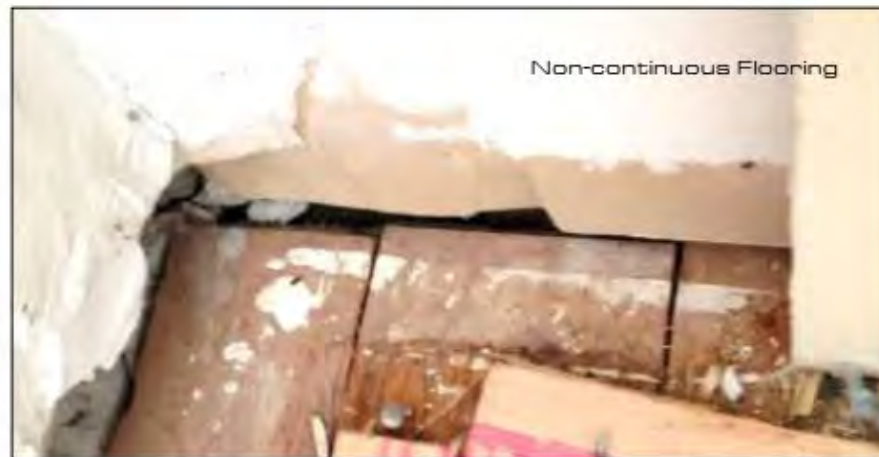
Non-continuous Flooring

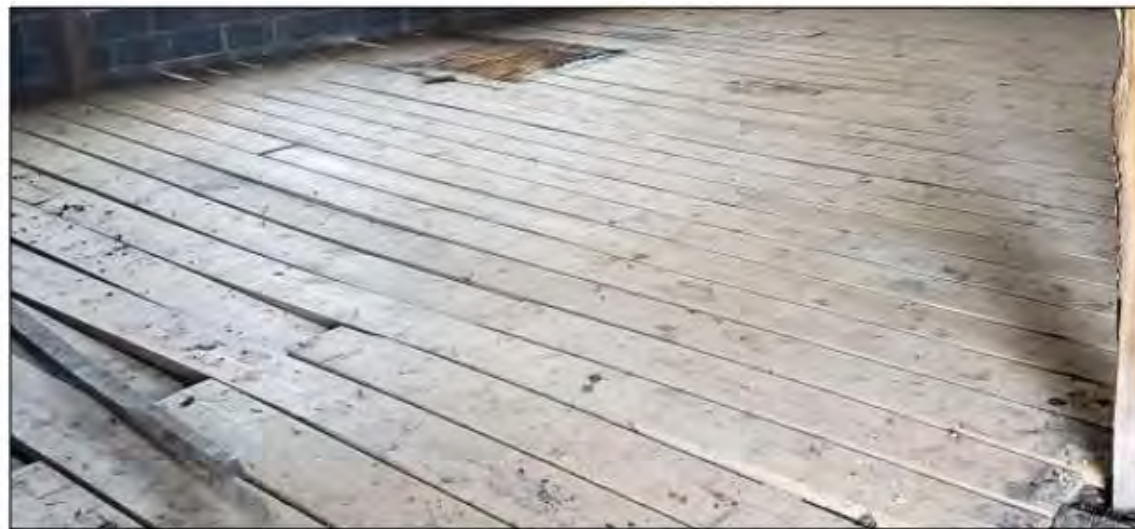
Dimensional Lumber Flooring at East End

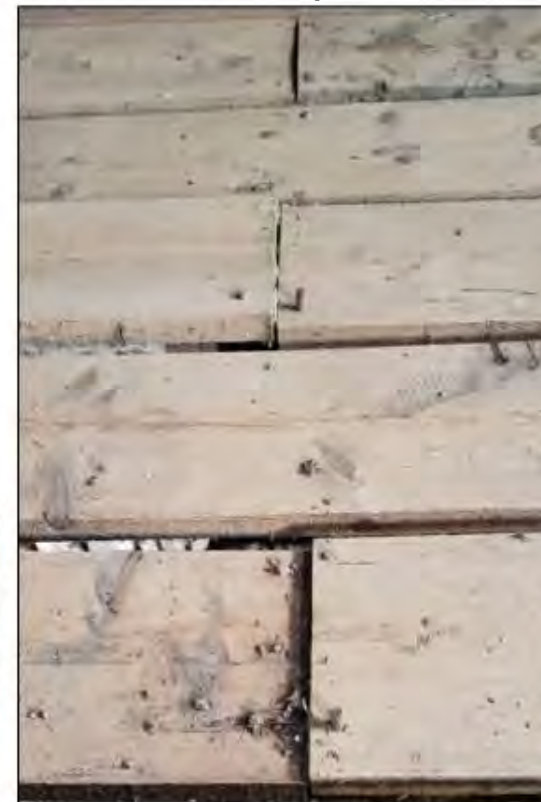
Wooden Pegs

Change in Flooring Materials

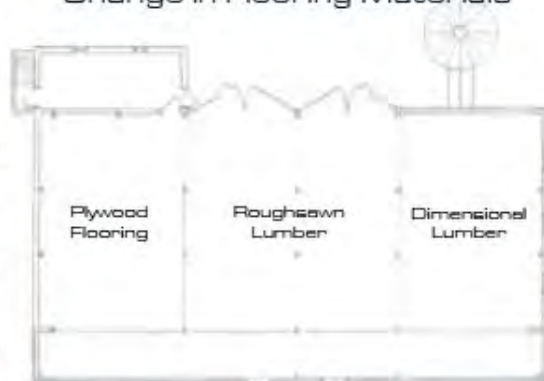
Roughsawn Lumber Flooring in Center

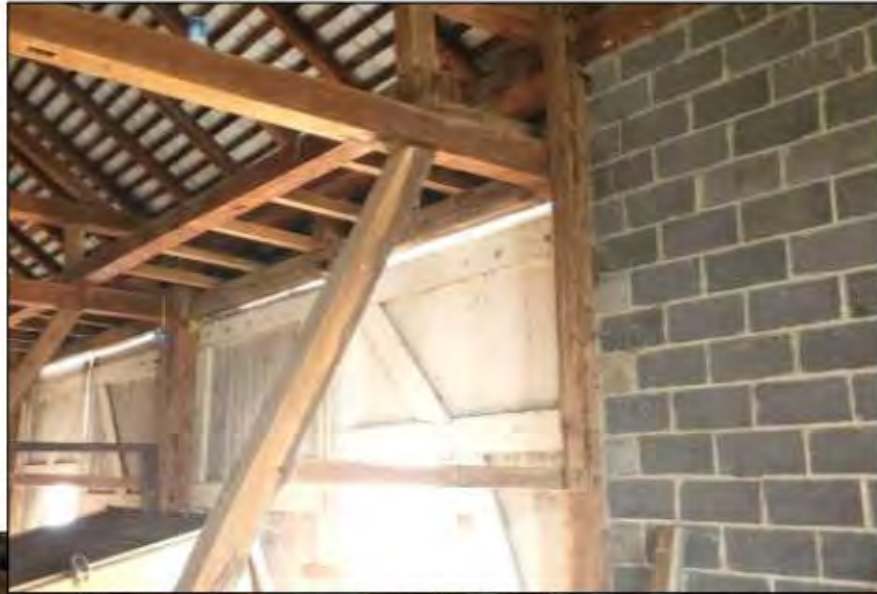
Change in Wall Construction

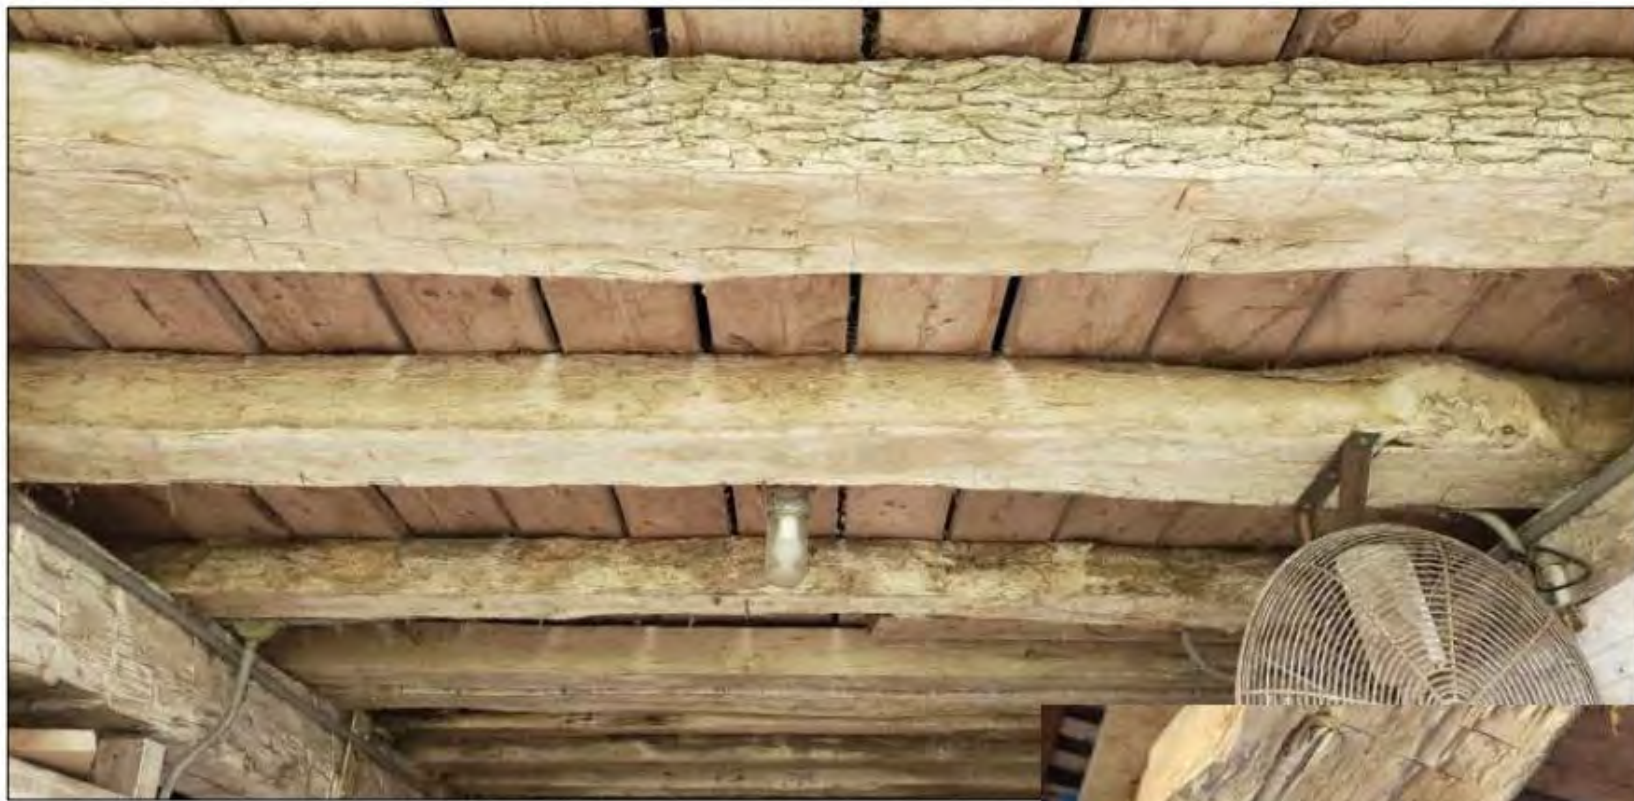
Massive Hand-hewn Lumber
