1215 McCormick Road

A Presentation in Two Acts

Act One – Residence

Act Two – Barn

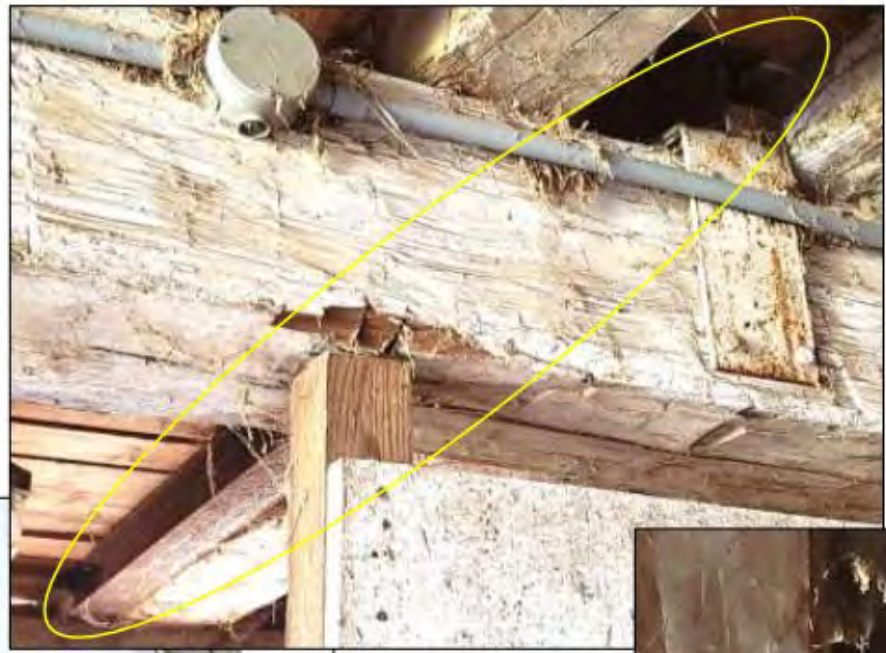
Inserted Steel Beams
Inside Barn

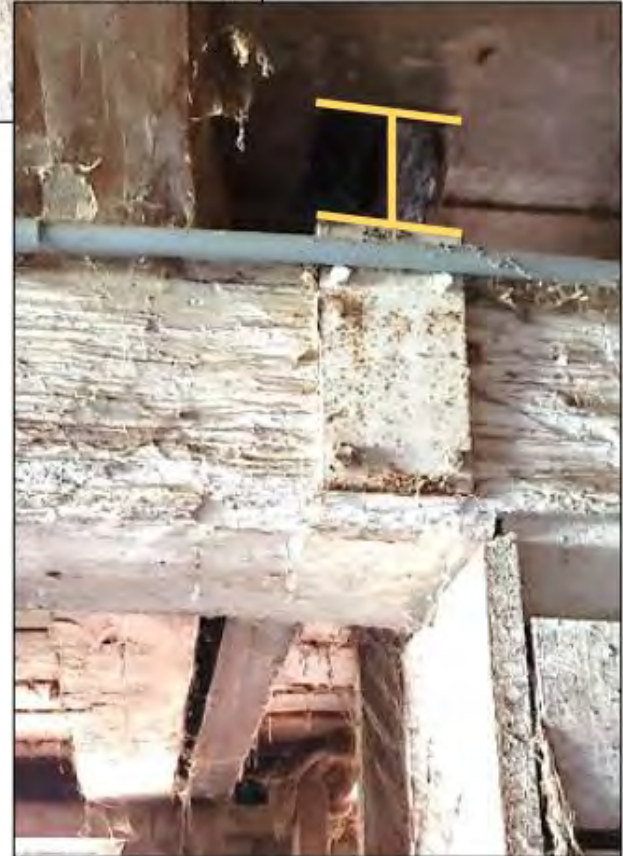
Inserted Steel Structure
